**North Slope of Alaska ARM Facilities
Monthly Status Update
Sandia National Labs**

May 2017

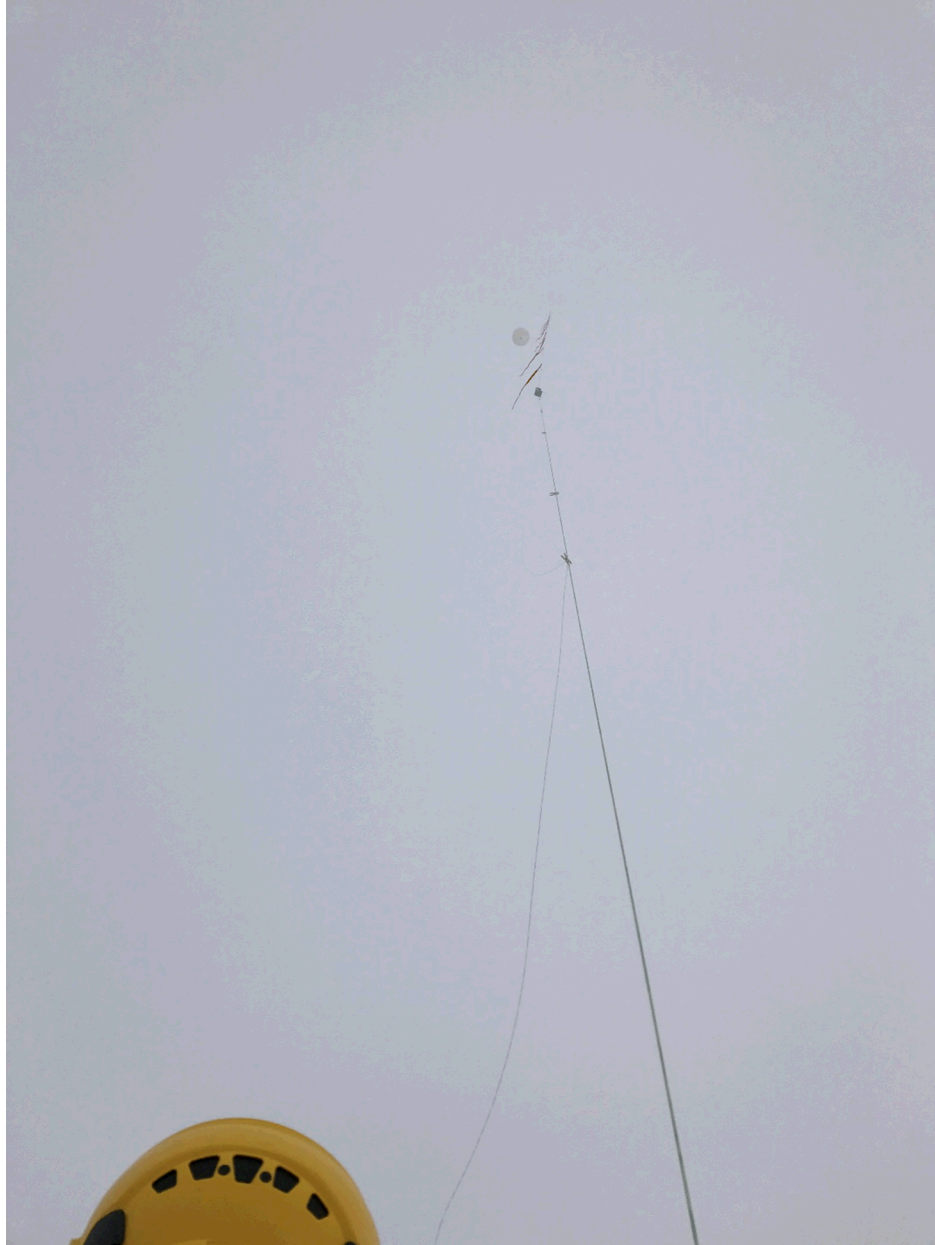
- The afternoon AMF3 radiosonde launches at 23:30. We reached 680m AGL and then plugged in the DTS at 23:32. Immediately after observing the first DTS trace we could see that the fiber was broken at 400m, almost exactly where the POPSs and CPC were on the tether – which was puzzling. Shortly after the observers advised us that the radiosonde was not gaining altitude and had ended its sounding. We began to descend the TBS and discovered that the radiosonde had become entangled in our tether at the POPSs and CPC and broken the DTS fiber. After untangling, we descended for the day.

Figure 1: Radiosonde balloon entangled in TBS

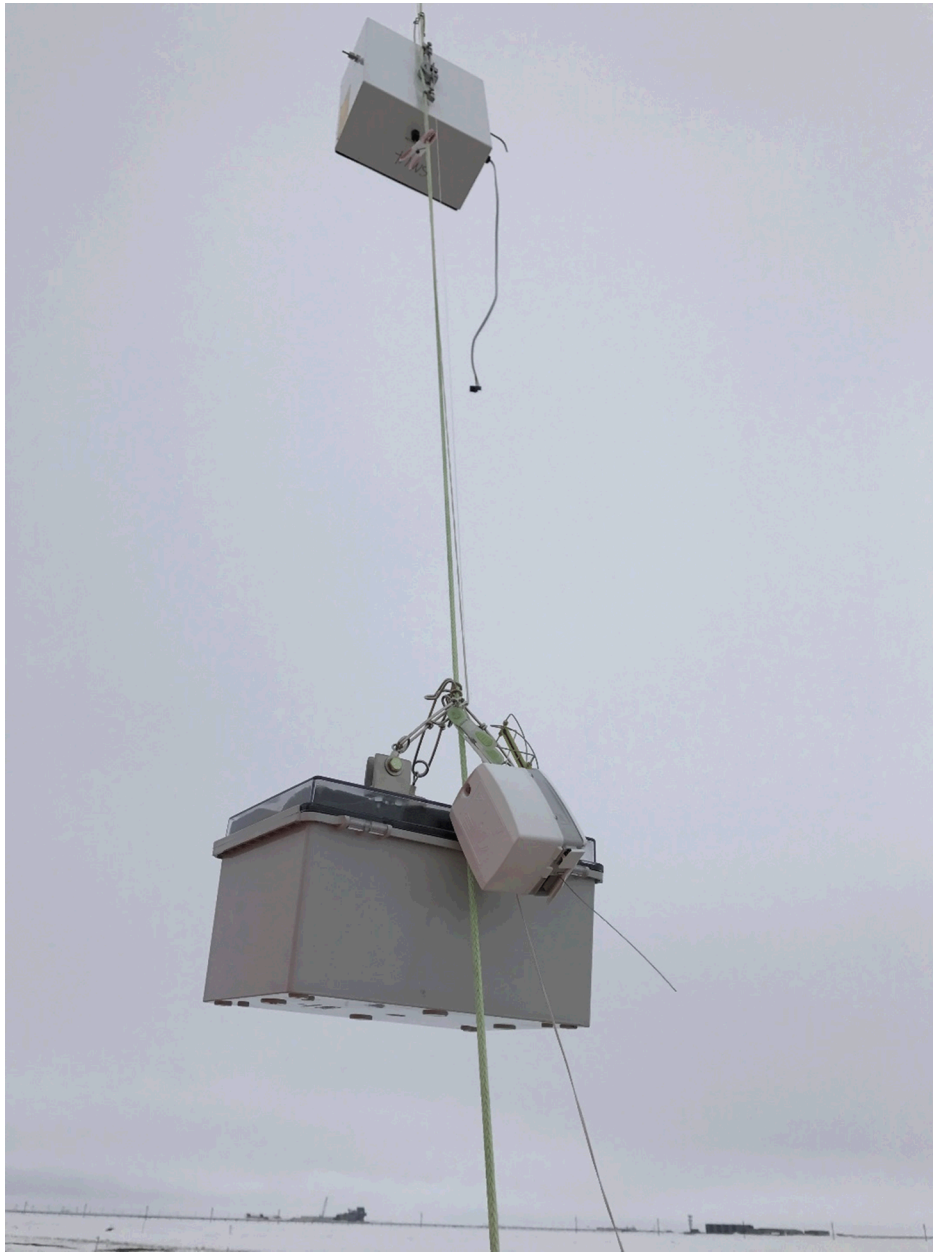
We can fix the DTS fiber, but the data from today will be invalid after 400m AGL. Upon descending, we also realized the radiosonde knocked the inlet off one of the POPS – and we could not find it on the ground. We should be able to make another inlet with spare parts. The observers have advised they will coordinate with us going forward to launch the radiosondes downwind of the TBS.

Figure 2: Radiosonde entangled on TBS CPC with POPS missing inlet above

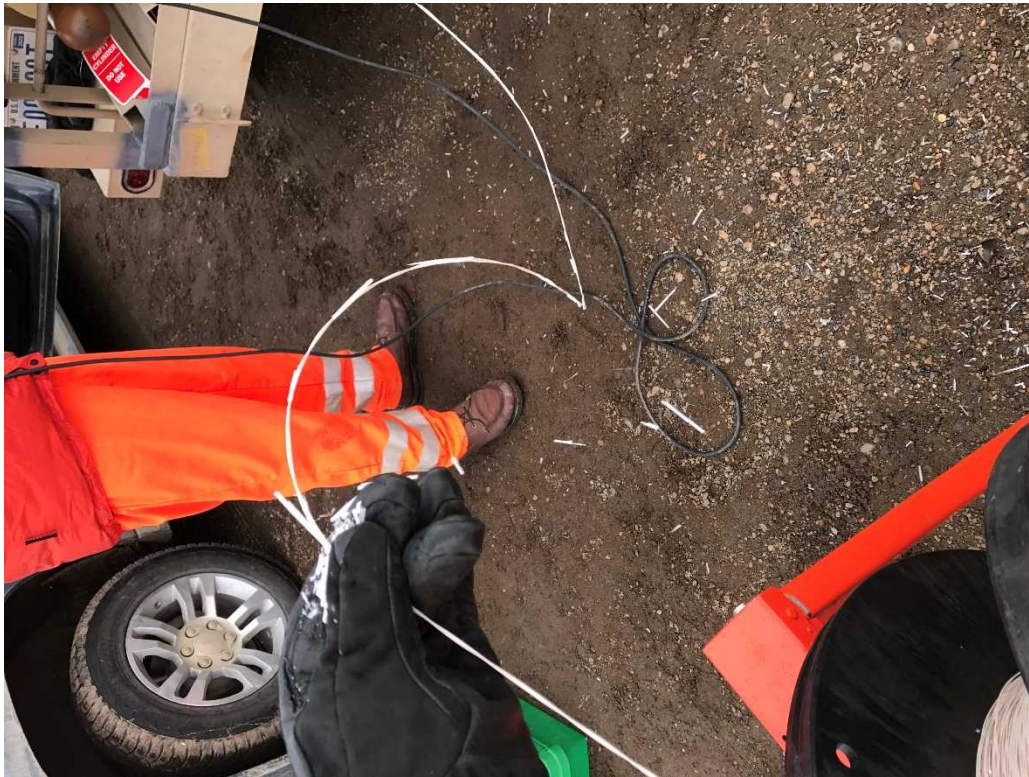
Figure 3: Light icing on DTS fiber around POPS and CPC

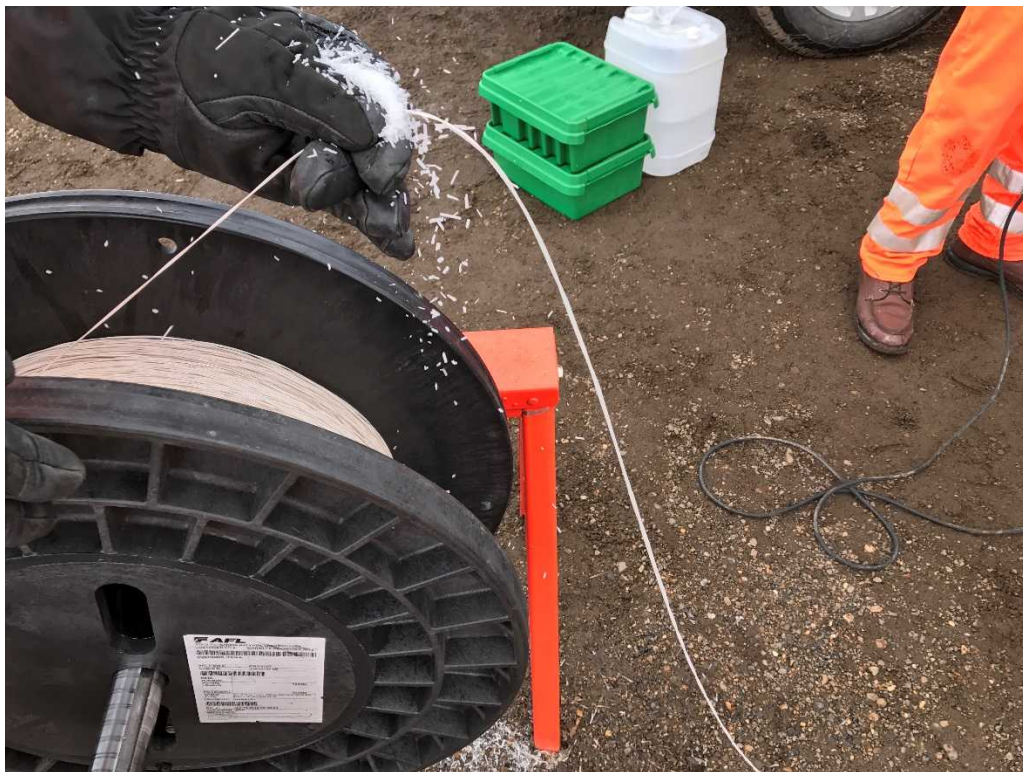
Figure 4: Heavier icing around DTS fiber starting ~5m above SN14 POPS

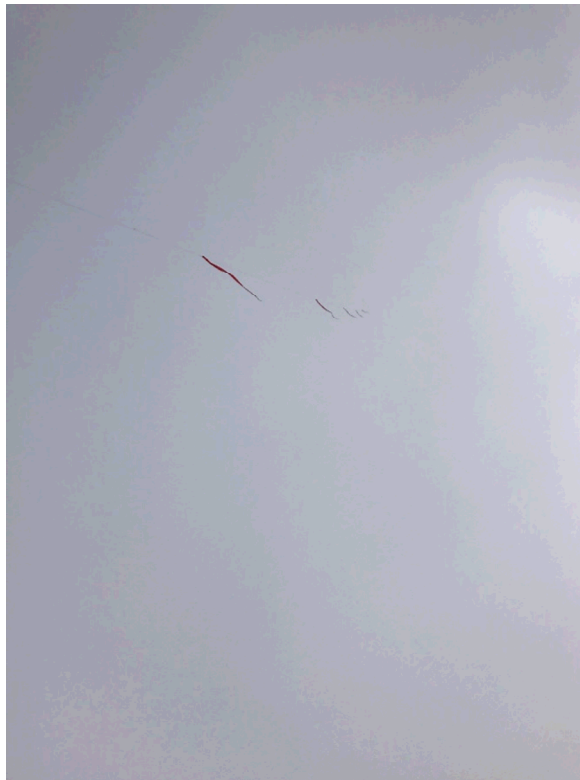
During Flight 3 it was observed that the handling issues began immediately below cloud top (~ 10m). The angle on the tether would divert from zenith almost instantly upon reaching this area. We realized that due to the very strong inversion today, the air in the balloon was making it stable and causing it to sink in the comparatively warmer air at and above cloud top. Once we diagnosed the issue, we ascended to right below cloud top during Flight 4 where the balloon maintained normal lift. The balloon was left in the hangar vertically overnight to allow more air to be vented from the base of the balloon tomorrow and additional helium added.

Figure 5: Tether into clouds on Flight 1

Failures: Air in balloon prevented flight above cloud top so POPS could not be ascended to above cloud top.

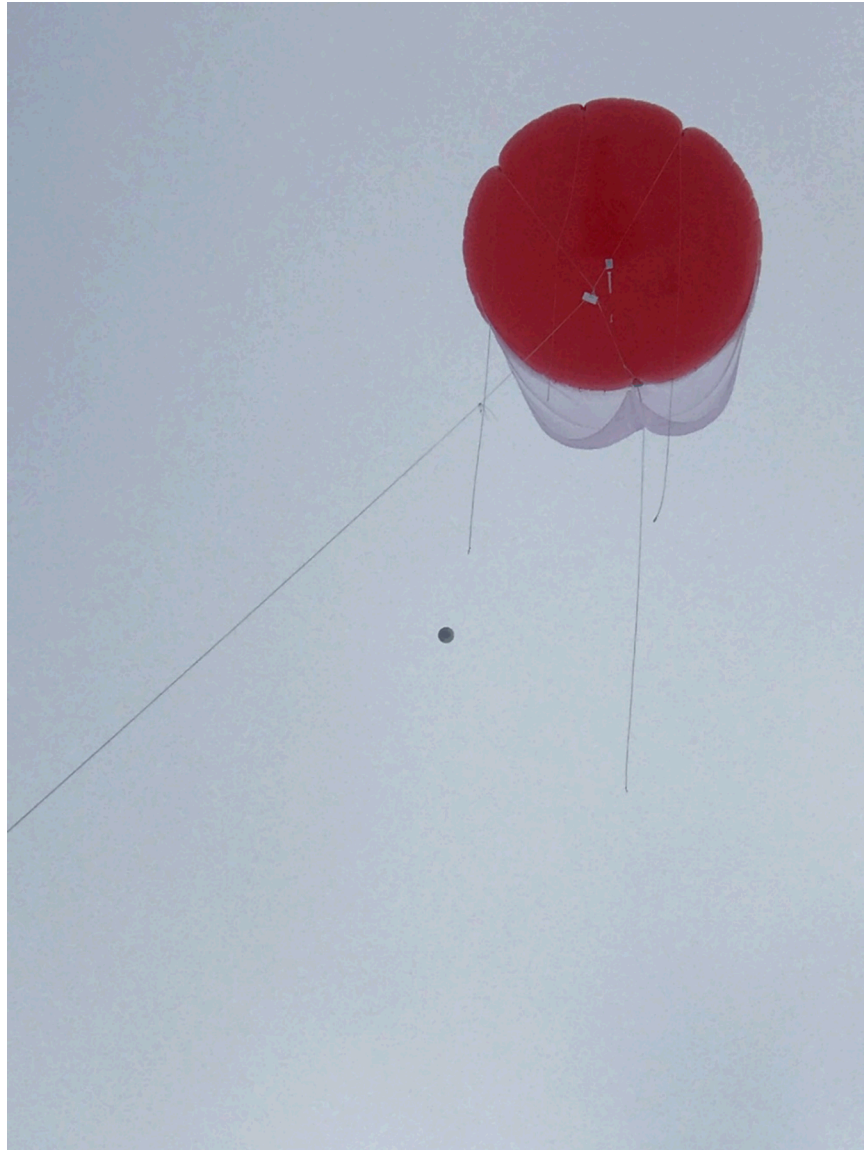
Failures: Radar calibration flight not very successful due to handheld radios not allowing much communication between TBS and radar staff unless radar staff came out of radar shelter.

Figure 6: Radar calibration sphere in flight below balloon and POPS

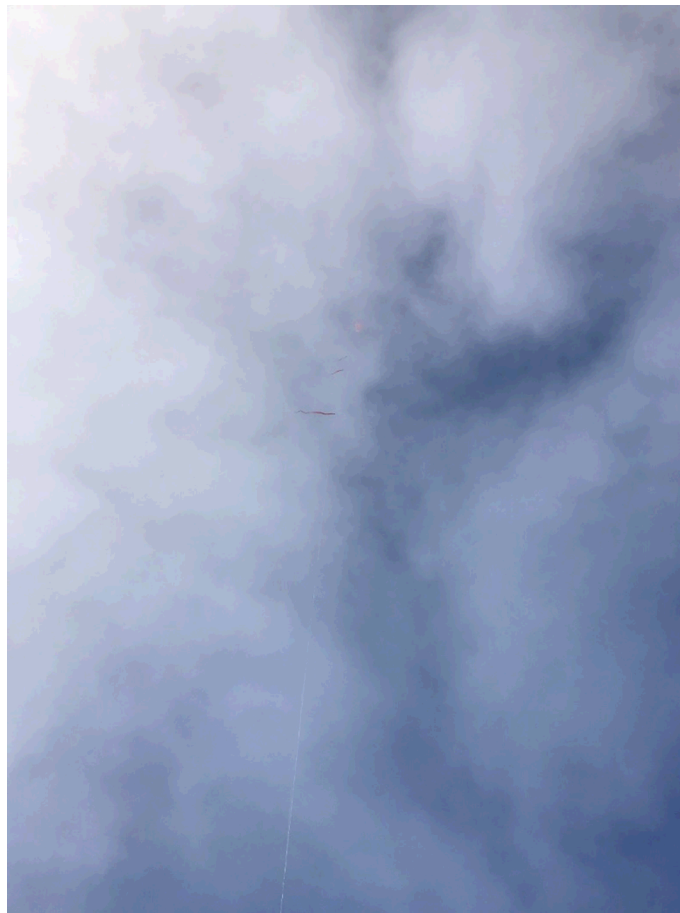
Figure 9: Aerostat barely visible through clouds while on descent during Flight 2
